## PRELIMINARY REPORT ON THE SECOND EXCAVATION SEASON OF THE ARCHAEOLOGICAL EXPEDITION TO WAD BEN NAGA

Pavel Onderka\*

**ABSTRACT:** During the second excavation season, the Archaeological Expedition to Wad Ben Naga focused on (1) delimitation of the archaeological registered land of the site of Wad Ben Naga, (2) revising excavation of several structures unearthed during the Sudanese excavations of 1958–1960 and survey of the so-called Eastern Temple (WBN<sup>1</sup> 500) and (3) conservation of rooms at the southern entrance of the so-called Palace of Amanishakheto (WBN 100).

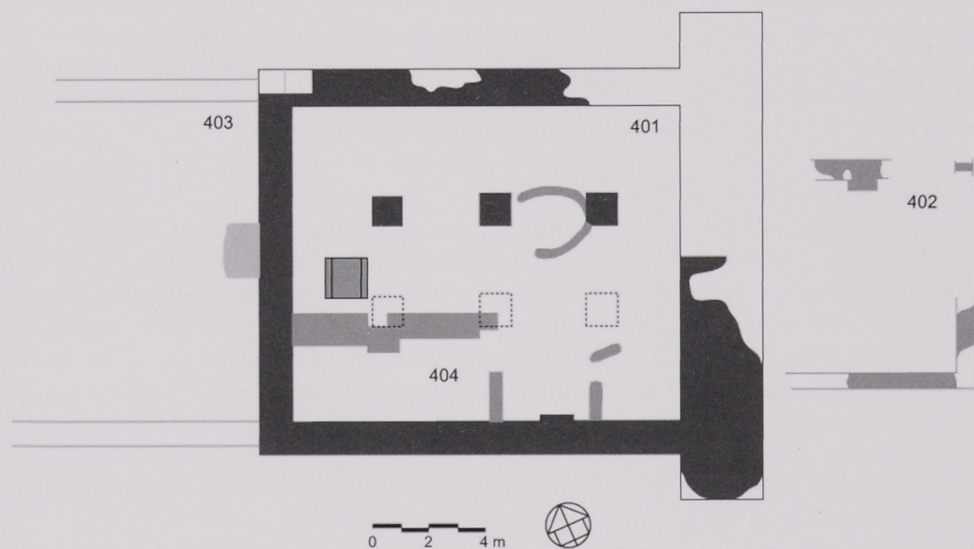
Fig. 2: The Small Temple (WBN 500) [illustration by Pavel Onderka].

The Small Temple (Fig. 2, Pl. 1) was unearthed by Said Thabit Hassan during the first excavation season of the Sudanese Antiquities Service at Wad Ben Naga in 1958–1959.<sup>2</sup> It was first described in detail by Ahmad Ali Hakem<sup>3</sup> and was re-excavated by Friedrich W. Hinkel who included its plan in the map of Central Wad Ben Naga published within *The Archaeological Map of the Sudan*.<sup>4</sup>

The objectives of the revising excavation were to obtain a detailed plan of the structure and to possibly identify and verify building phases previously suggested for the building in question. The secondary excavations confirmed the minimum of two phases of construction noted previously (preliminarily dated to the latter half of the Meroitic period, i.e. 1<sup>st</sup>–4<sup>th</sup> century CE) and the reuse of the partly collapsed building as a habitation by squatters (most likely during the post-Meroitic period, i.e. 5<sup>th</sup>–6<sup>th</sup> century CE).

The simple inner structured temple was originally a cella (WBN 401) with a pylon in front. Its roof was supported by three pairs of columns which stood on rectangular bases. Ahmad Ali Hakem mentions that “upon the bases rested columns built from specially made segments of fired terracotta”,<sup>5</sup> however only a single possible example of these was discovered during the revising excavations. Traces of white plastered floor were attested.

The second phase is likely represented by a structure (WBN 402) appended to the entrance of the temple, as well as an outbuilding adjoining the rear of the temple (WBN 403). For the time being, the function of the latter building may not be determined with certainty. One may rule out the possibility that this was a contra temple. The outbuilding must have been either a storage space or more likely a habitation. Another example of habitation (or an atelier) adjoined to a temple may be found north of the so-called Eastern Temple (WBN 500; cf. below) The foundation of northern and southern walls of WBN 403 are very similar to those of *House A* and *B* (WBN 600; cf. below).

Hinkel's plan depicts WBN 402 as a building consisting of two separate rooms and directly adjoining to the pylon, but the acquired archaeological evidence seems to point to the fact that WBN 401 and WBN 402 (despite situated on the same axis and forming parts of a single complex) were not touching each other. Both WBN 401 and WBN 402 were built of red bricks, while WBN 403 of mud bricks. Before WBN 403 was annexed to the main building, the northern wall of WBN 401 must have had serious problems with stability, a fact manifested by two stones (likely segments of a statue's stand) supporting the north-west corner of the WBN 401 indicating a reconstruction of the building in the times when a cult was practiced in the building.

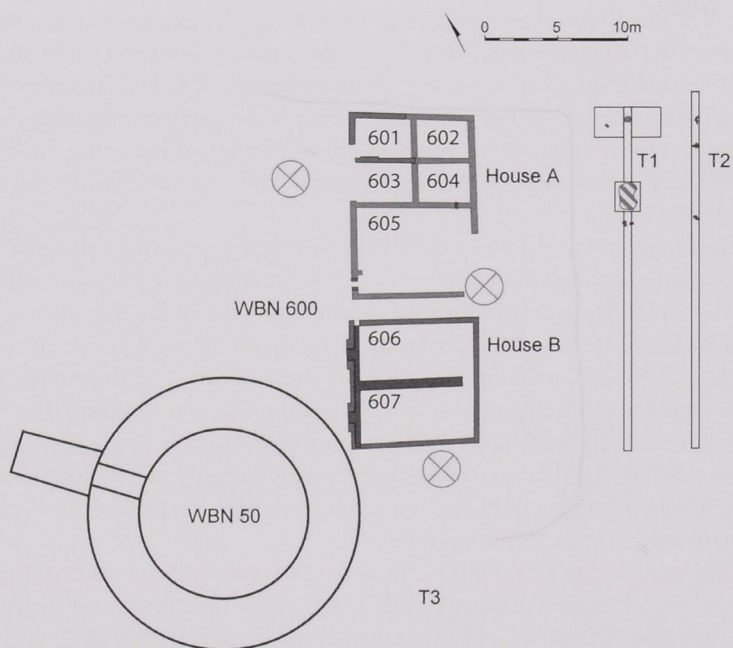
Fig. 3: The Circular Building complex [illustration by Vlastimil Vrtal].

Another structure discovered in the course of the Sudanese excavations at Wad Ben Naga are two 'houses' (WBN 600, Fig. 3, Pl. 3)<sup>7</sup> located east of the Circular Building (WBN 50<sup>8</sup>). Both structures were re-excavated by Hinkel in 1983 and their (inaccurate) ground plans published within *The Archaeological Map of the Sudan*.<sup>9</sup> Neither of the above-mentioned publications gives information concerning material used for the construction of the houses or mentions other important details. The houses were once again cleared from the sand in order to obtain the missing data.

Vercoutter wrongly stated that the houses were built of only mud-bricks as red-bricks were also used.<sup>10</sup> The western, southern and northern walls of WBN 605 were made of red bricks, while the mud bricks were used everywhere else.

*House A* consisted of five separated rooms (WBN 601–605), out of which three or four were roofed. Only the remains of the lower courses of masonry were unearthed still *in situ*.

*House B* consisted of two identical rooms (WBN 606–607) with individual entrances that were interpreted as storerooms. The hypothesis has been verified by the discovery of four seal imprints in front of the door to WBN 606.<sup>11</sup>

All the entrances to the houses were oriented towards the west, i.e. towards the Circular Building. The buildings' orientation and close proximity to the Circular Building makes it very probable that the houses were subsidiary to it. One would logically expect that such an extraordinary structure – no matter what its function was – would need subsidiary buildings to accommodate its personnel and to provide storerooms for equipment connected with its maintenance.

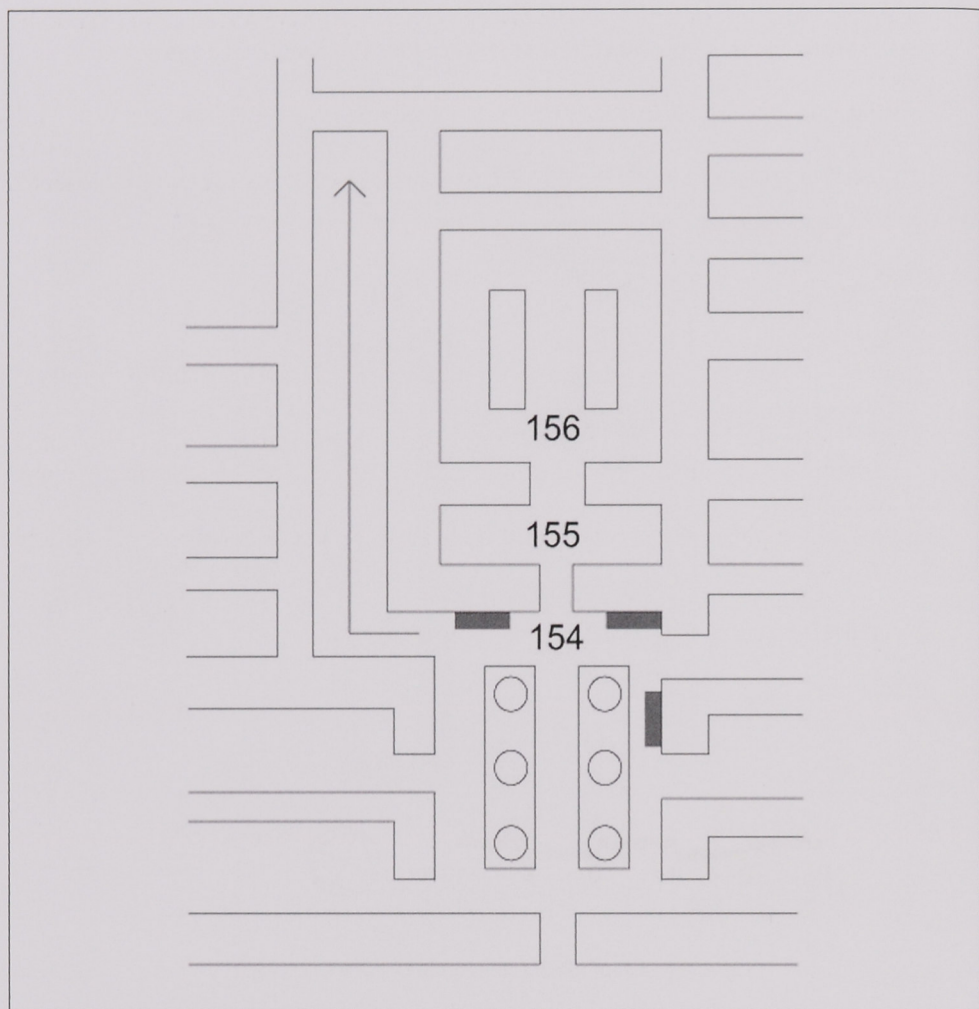
Fig. 5: Southern Entrance to the Palace of Amanishakheto [illustration by Pavel Onderka].

During the present excavation season, the conservation work was directly connected to the re-excavation work which focused on the southern entrance system (WBN 154–157), especially rooms WBN 154 and WBN 156 (Fig. 5).

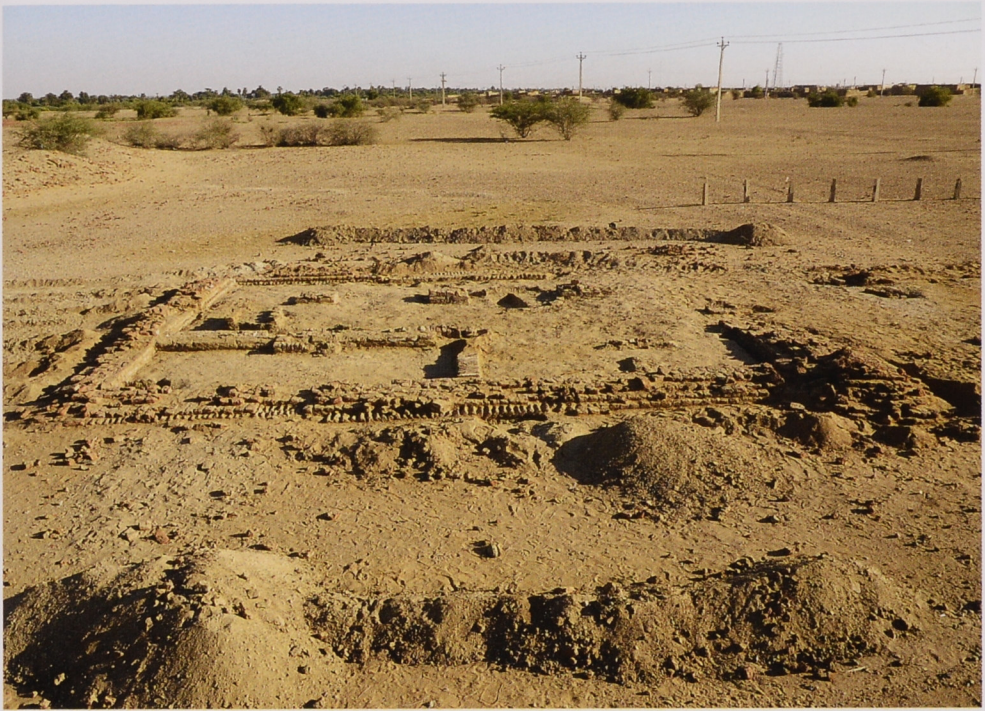
Pl. 1: The Small Temple (WBN 400) [photo by Pavel Onderka].

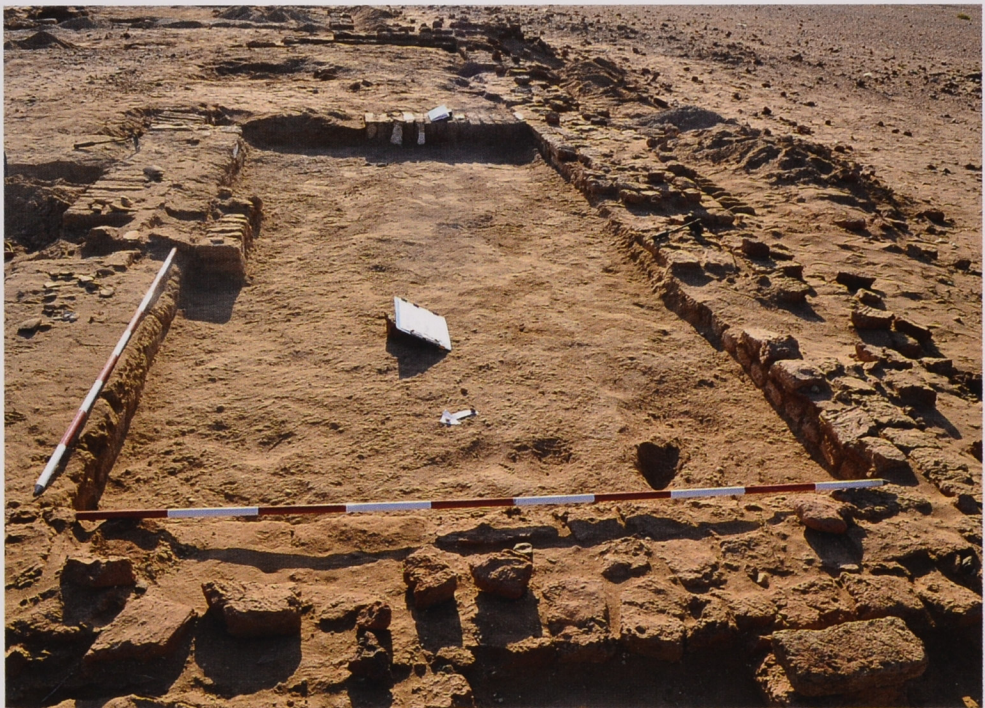
Pl. 2: Room WBN 404 after clearing [photo by Miroslav Vaškových].

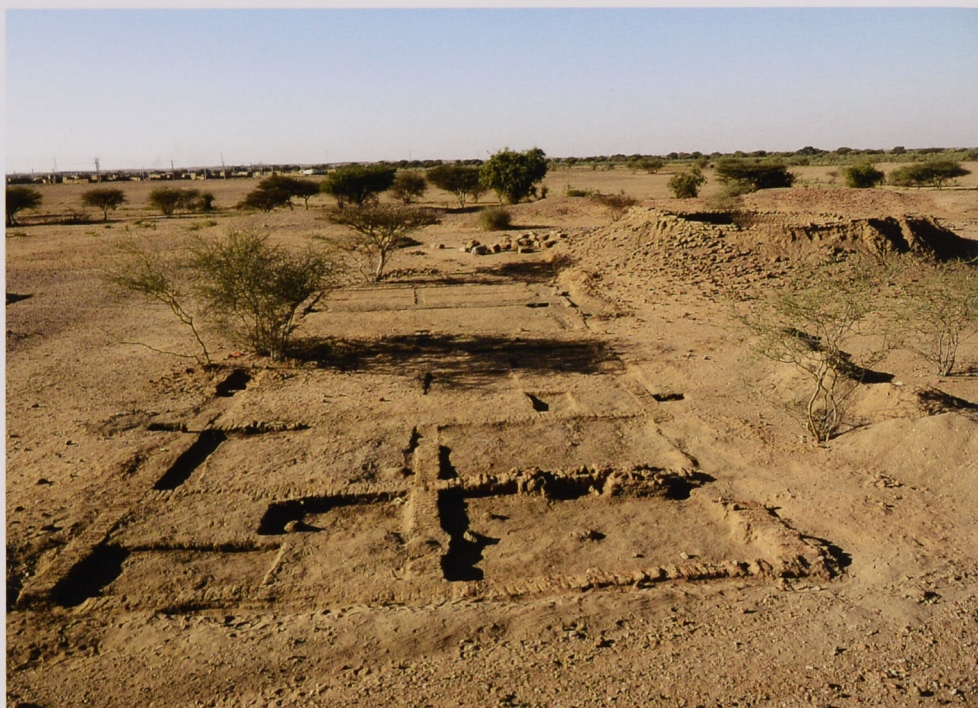
Pl. 3: Houses A and B (WBN 600) [photo by Pavel Onderka].

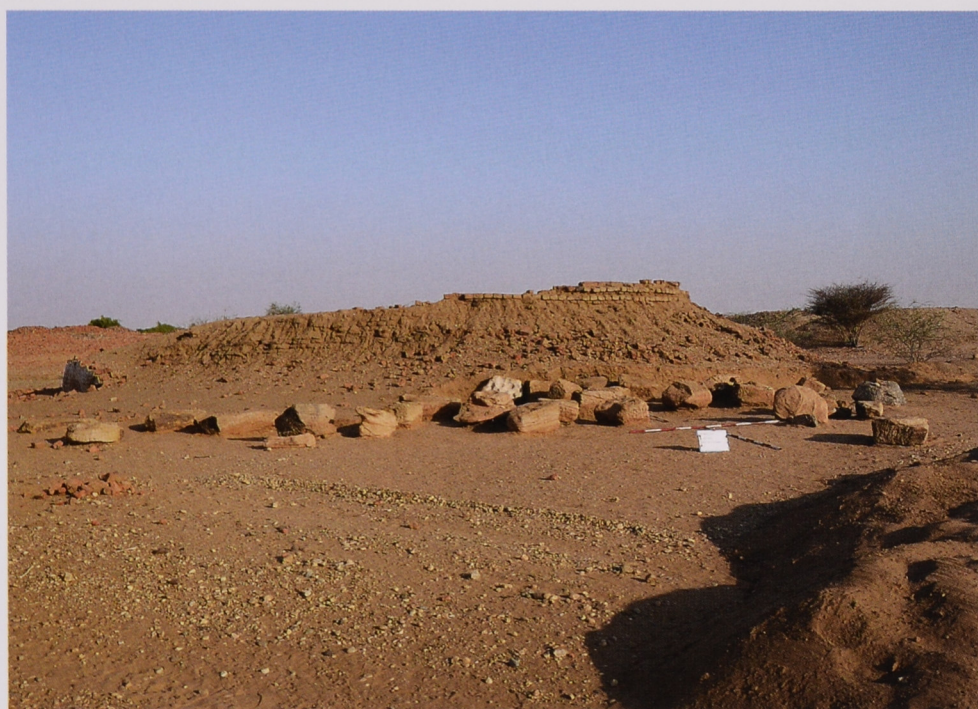
Pl. 4: Sandstone blocks in T3 [photo by Pavel Onderka].

in the distance of 5 and 20 meters, respectively. The last one (T3) comprised cleaning of the area south to *House B* (WBN 606–607) and east to the Circular Building (WBN 50, Pl. 4).

In the sector designated as T3 (ca 17.00 by 10.00 meters), large sandstone blocks were secondarily deposited in connection with the Sudanese excavations of 1958–1959. Beside the stones, an architectural feature now believed to be the top collar of the dome-shaped roof of the Circular Building (WBN 50) was discovered together with three fragments of an altar (?).

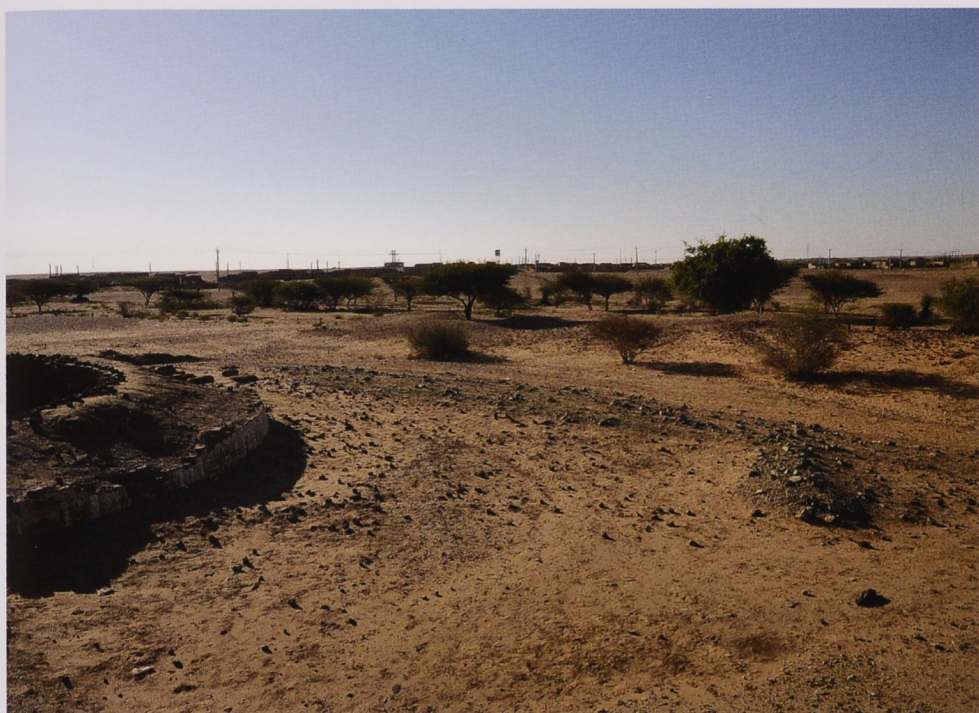
Pl. 5: Collapsed wall WBN 53 [photo by Pavel Onderka].

To the south of the Circular Building (WBN 50), the remains of a destroyed stone wall (WBN 53) were identified. The collapsed wall separates the Circular Building from the small present day wadi located immediately behind it (in publications wrongly identified as the southern branch of Wadi Kirbikan). The collapsed wall is some 30 meters long and has two main segments. The larger segment includes a small projection in the direction towards the ascending ramp of the Circular Building (Pl. 5).

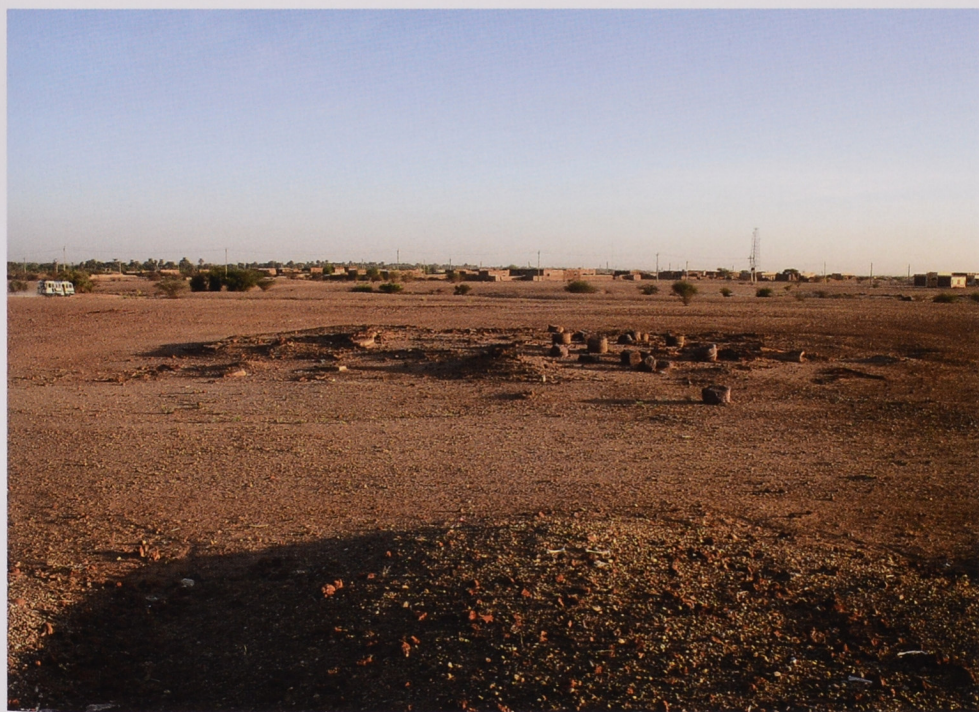
Pl. 6: The Eastern Temple (WBN 500) [photo by Pavel Onderka].

Within the preparation for the third excavation season, the Expedition took measurements of the so-called Eastern Temple (Fig. 4, Pl. 6) that had not been published in the previous reports from the excavations and surveys carried out on the temple. So far, two ground plans of the temple have been published. The earlier one published by Vercoutter<sup>12</sup> is highly erratic. The later one published by Hinkel is, as far as we can judge from the preliminary survey, accurate in dimensions, however, misses exact measurements.<sup>13</sup> The ascertained dimensions are: width of the pylon 19.50 m; the width of the temple 15.50 m; the length equals 23.70 m. The measurements are preliminary and were taken as data of general comparison.

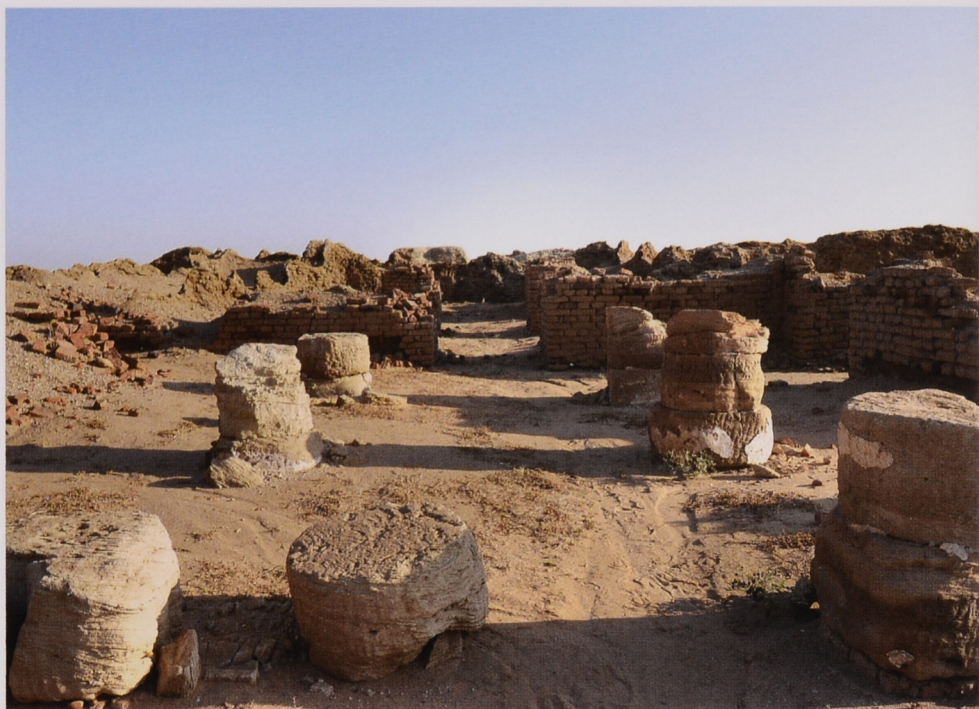
Pl. 7: The Southern Entrance to the Palace of Amanishakheto [photo by Pavel Onderka].

The original floor of WBN 154 (Pl. 7–9) was taken away already during the second excavation season of the Sudanese expedition.<sup>14</sup> Only several traces of the plastered floor were possible to be identified at present. The roof of WBN 154 was supported by two lines of three columns each. Each pair of the columns had a different type of capitals: (1) lotus-shaped, (2) decorated with Amun's ram heads and (3) floral ones. The capitals are deposited in front of the southern façade of the Palace (WBN 100) and had already been documented during the first excavation season of the Archaeological Expedition to Wad Ben Naga. Each line of columns stood on deep basements the exterior of which was made of red bricks and the interior of mud bricks. Their tops were unearthed already during the Sudanese excavations. Their inner edges were erratically interpreted as dividing WBN 154 into three sections by Hinkel.

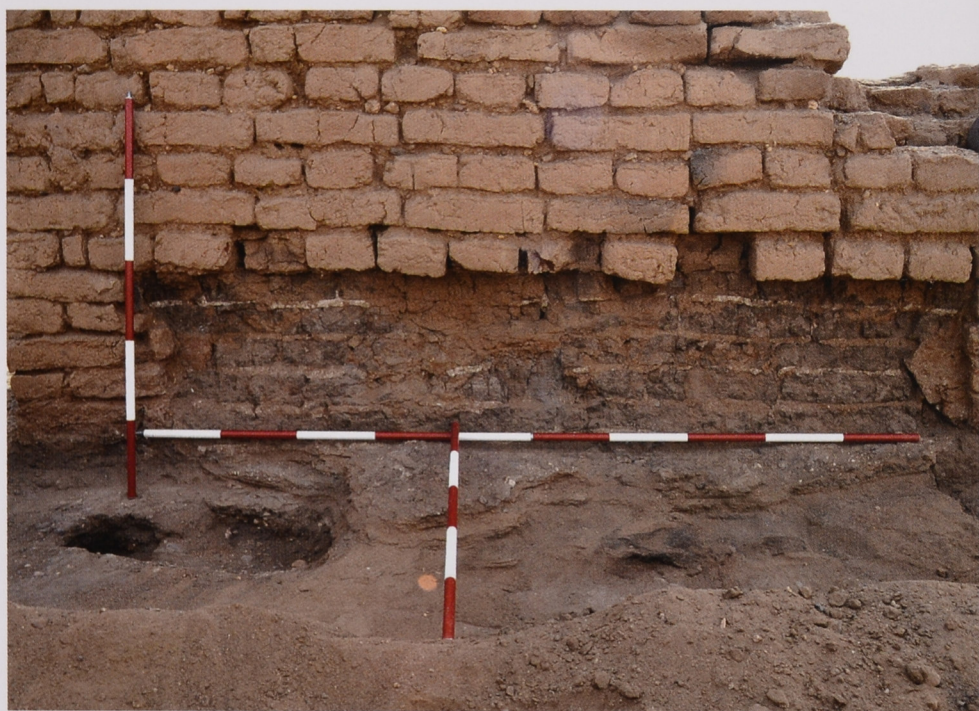
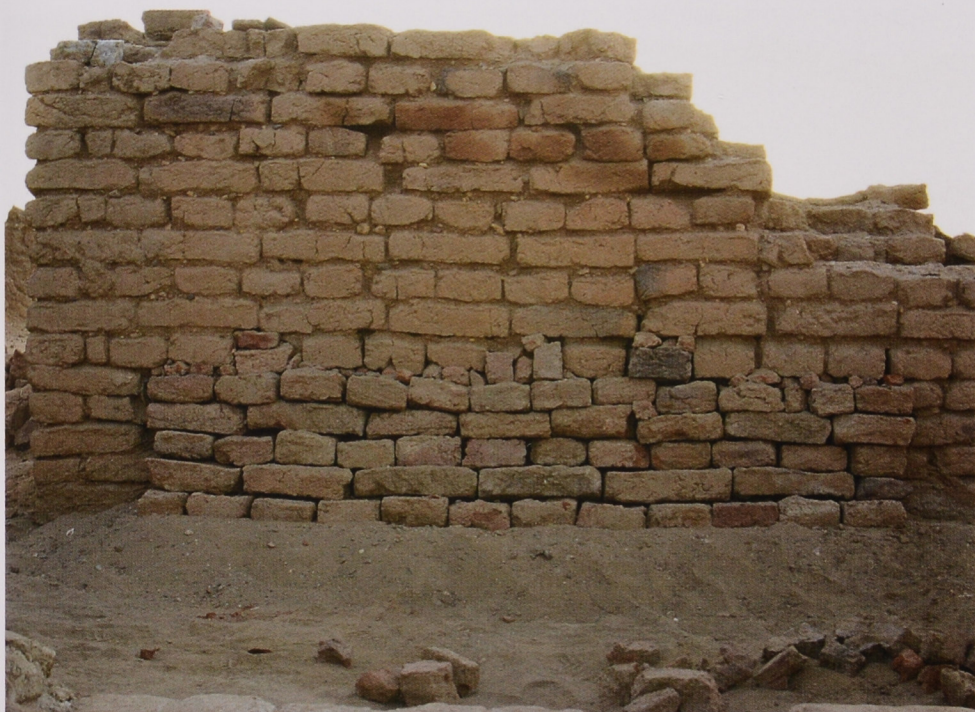
Pl. 8: Wall 154/134/135 before conservation [photo by Dušan Nováček].

Pl. 9: Wall 154/134/135 after conservation [photo by Dušan Nováček].

In the connection with the conservation of wall segments in the northern part of WBN 154, an interesting feature of the room was identified. The long segments were once supported at their base by means of mud brick benches (mastabas) inserted into the mass of the walls giving the lower parts of the walls better stability as they did not stand on sufficiently stable foundations (probably only on leveled terrain). The benches themselves are unfortunately not preserved but they are archaeologically demonstrable through gaps of identical dimensions in the lower courses of masonry and by remains of headers that had partly formed the bodies of the mastabas, as the mud bricks of the benches were interconnected with those of the walls' cores. The benches adjoined wall segments 154/155/W (suggested dimensions of the bench ca. 205 x 38, h. 43 cm), 154/155/E (ca. 205 x 38, h. 43 cm), 154/134/135 (ca. 210 x 35, h. 43 cm) and most likely also 154/111 (covered by upper courses of the fallen wall). The empty spaces after the original mud brick bench within the red brick walls were filled in by red bricks with the intention to prevent a potential collapse of the wall. The bricks were

fixed by mortar only in the case of 154/155/W as an enormous crack appeared in the middle of the wall shortly before the conservation works started. The conservation procedures were otherwise fully reversible.

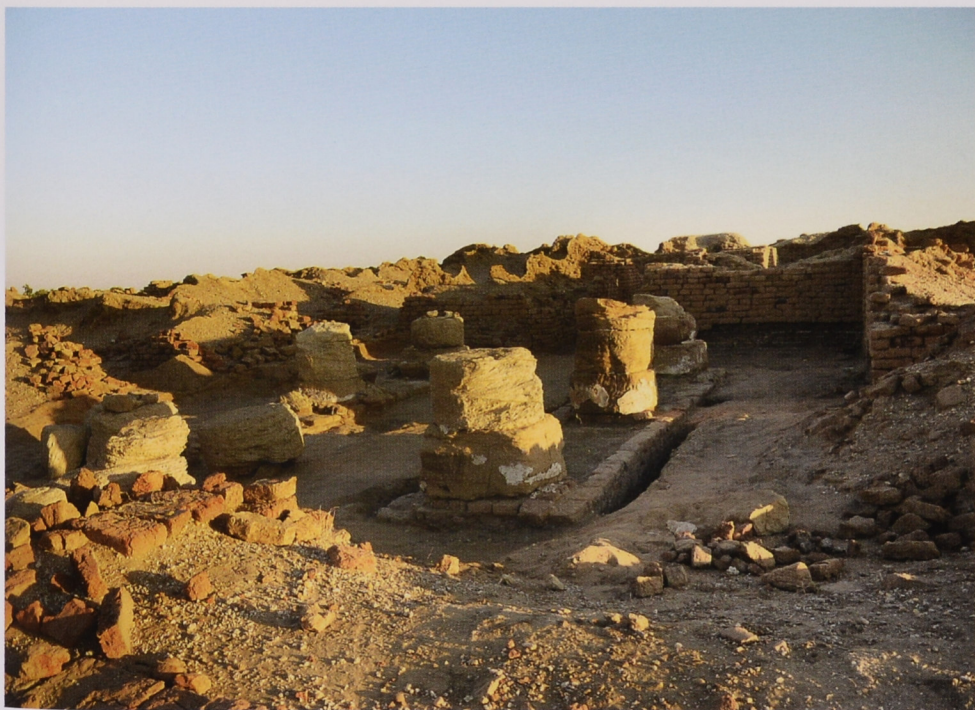
Pl. 10: Room WBN 154 in the course of cleaning [photo by Pavel Onderka].

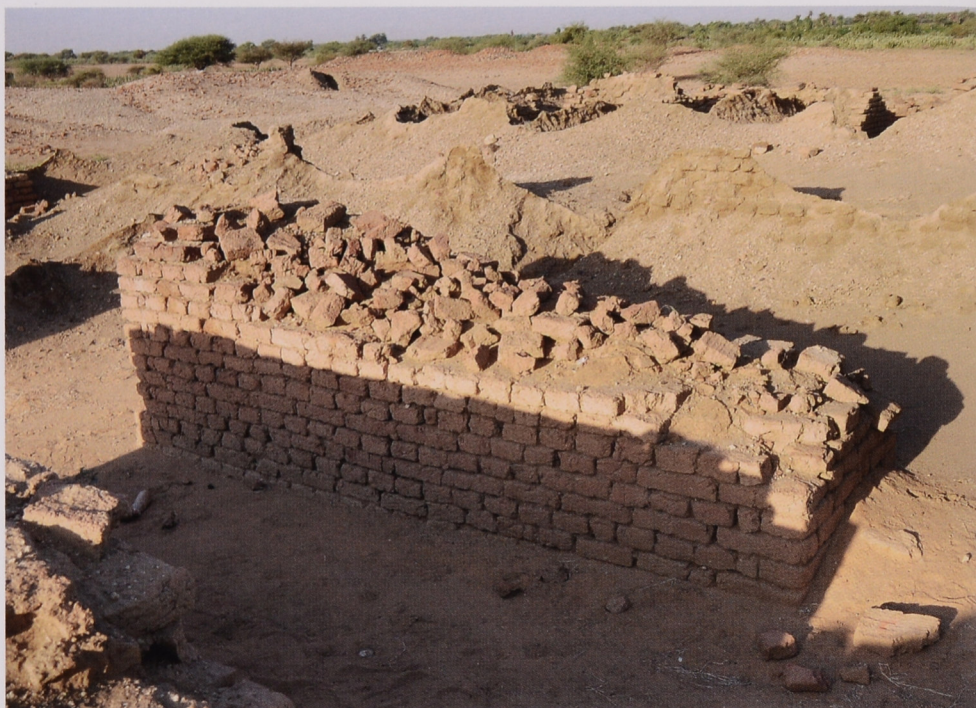
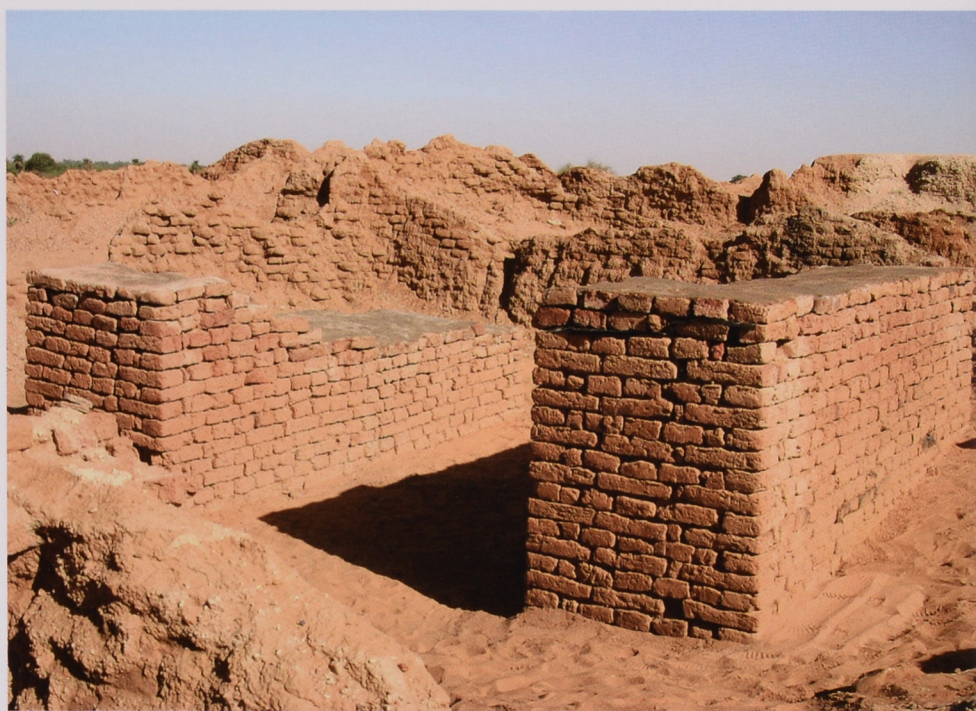
Pl. 11: Western pillar in Room WBN 154 before conservation [photo by Pavel Onderka].

Pl. 12: Pillars in Room WBN 154 after conservation [photo by Dušan Nováček].

Simultaneously with the works in WBN 154 (Pl. 10–11), conservation was carried out also on two huge pillars of WBN 156. The eastern pillar was cleaned from sand and soil until the lower limit of the basement. The original floor was recognizable on the profile of the pillar.

The pillar stands on a mud brick platform. Its exterior is made of red bricks and the interior filled with mud bricks (similarly to the basements of columns at WBN 154). It seems likely that the pillars actually supported columns of the royal living quarters on the upper floor of the palace.

The tops of the pillars were cleaned and their inner structure documented. The tops were cover by a geo-textile upon which a course of red bricks casted over by a thin layer of concrete was placed. The measure is aimed at protecting the pillar from further rain erosion. The conservation intervention is fully reversible.
