## PRELIMINARY REPORT ON THE SEVENTEENTH EXCAVATION SEASON OF THE ARCHAEOLOGICAL EXPEDITION TO WAD BEN NAGA

**ABSTRACT:** The seventeenth excavation season of the Archaeological Expedition to Wad Ben Naga focused on the continued exploration of the so-called Isis Temple (WBN 300), the Palace of Queen Amanishakheto (WBN 100), and cemetery WBN C260.

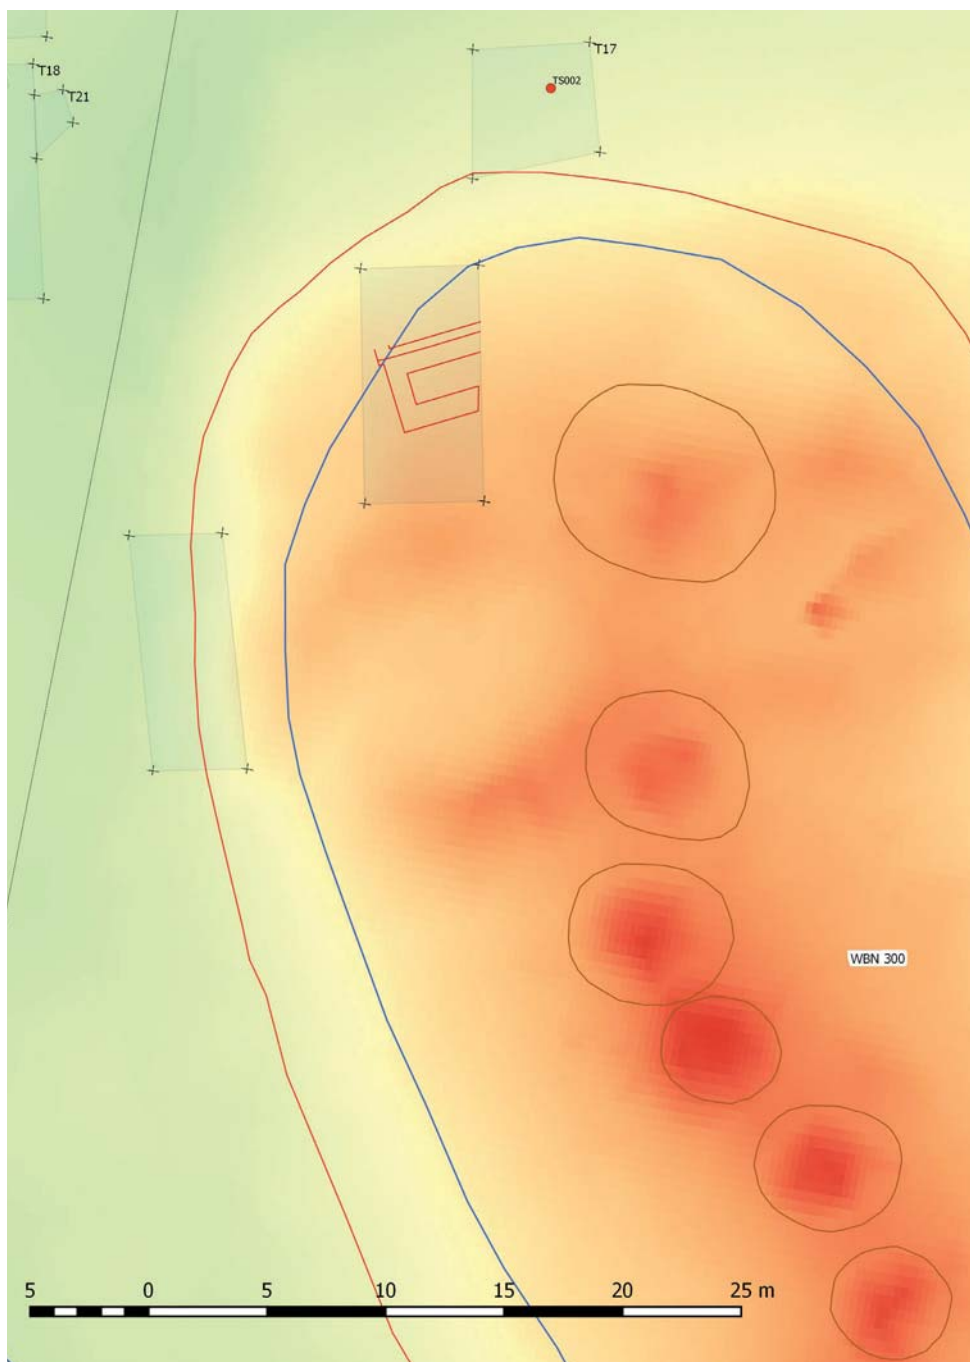
Fig. 1 Northern end of kom C with with the designation of the excavated area (Illustration: Vlastimil Vrtal).

In the course of the seventeenth season, two squares, namely T61 and T64A<sup>2</sup> located on the northern end of the kom C, were excavated [Fig. 1]. The other two squares, namely T62 and T67, were set to the west of Kiosk WBN 390. No direct or indirect

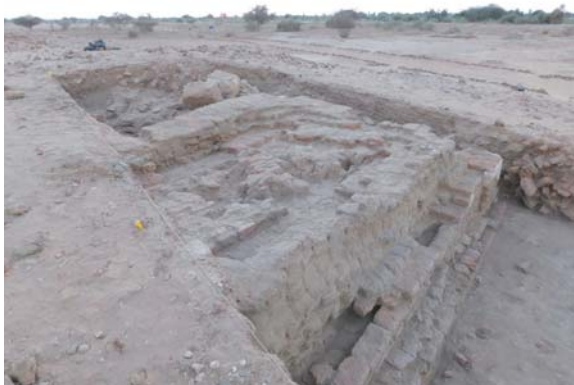
Pl. 1 Brick structure FEA 212 (Photo: Pavel Onderka).

T64A (5.0 m × 10.0 m) was located on the northern slope of kom C, in the area where geophysical survey indicated existence of a substantial brick structure [Fig. 2; Pl. 1]. The excavations revealed a complex archaeological situation dominated by a massive brick structure (FEA 212; north-south dimension ca. 3.6 m; the west-east dimension may not be determined, as the structure exceeds the borders of the square; however, it is certainly more than 4.5 m long).

The brick structure (FEA 212) was constructed in vertical layers. The core was built of fired and un-fired bricks laid on the long narrow sides. Massive walls with an inner fired brick casing surrounded the core. The northern wall also possessed fired brick casing, covered with a relief-modelled layer of plaster (however, only a single fragment of the modelled casing was preserved still *in situ* on the wall, a fact which actually prevented us from any estimation of the depicted topic). Numerous fragments of the (relief-modelled) lime plaster were discovered to the north of the brick structure. The fragments bore polychrome decoration in red, yellow, blue, black, and white. The eastern and southern walls of the structure were covered by mud plaster and slightly painted, as attested by some fragments of preserved polychrome decoration.

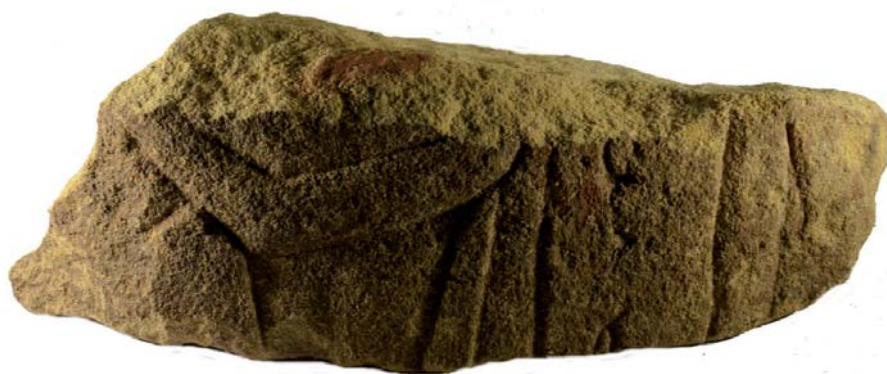
Pl. 2 Fragment of a column drum with the depiction of a king performing an offering  
(Photo: Pavel Onderka).

Numerous special-shaped bricks which once formed a cavetto cornice were discovered to the north and south of the structure. They either adorned the top of the structure itself or originated from the architrave of the door. Two blocks forming one corner of the cavetto cornice were discovered in the northwest corner of the square. In the southwest corner of the trench, four collapsed large sandstone rectangular blocks (FEA 211) which once likely formed jambs of a doorway or a pillar were discovered. In the southeast corner fragments of sandstone column drums bearing relief decoration were found. The biggest preserved fragment bears a depiction of an offering king [Pl. 2].

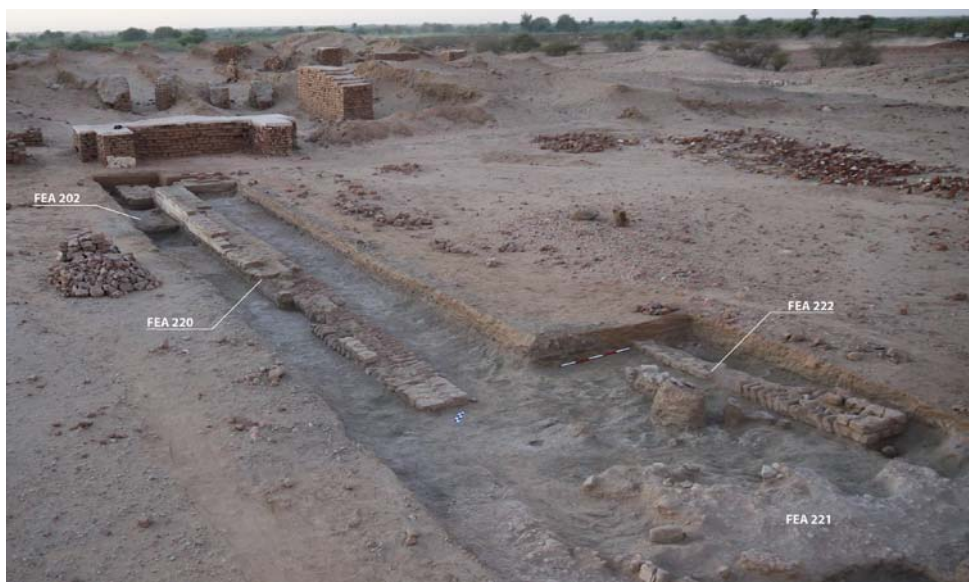
Pl. 3 Trench T63 at the end of excavations, viewed from the east (Photo: Vlastimil Vrtal).

Trench T63 was set in the area of the eastern exterior ramp (WBN 161–162), with dimensions of 22.0×3.0 m and covering the southern half of the ramp [Fig. 3; Pl. 3]. The trench was twice extended, once to the north (2.2×5.5 m), in order to record the limits of the northern wing of the ramp, and once to the west (1.2×1.0 m), in order to record the western limit of the ramp in room WBN 161. The ramp was previously excavated; the aim of the present excavations was to record the extent of the architectural remains of the ramp and the character of the entry area.

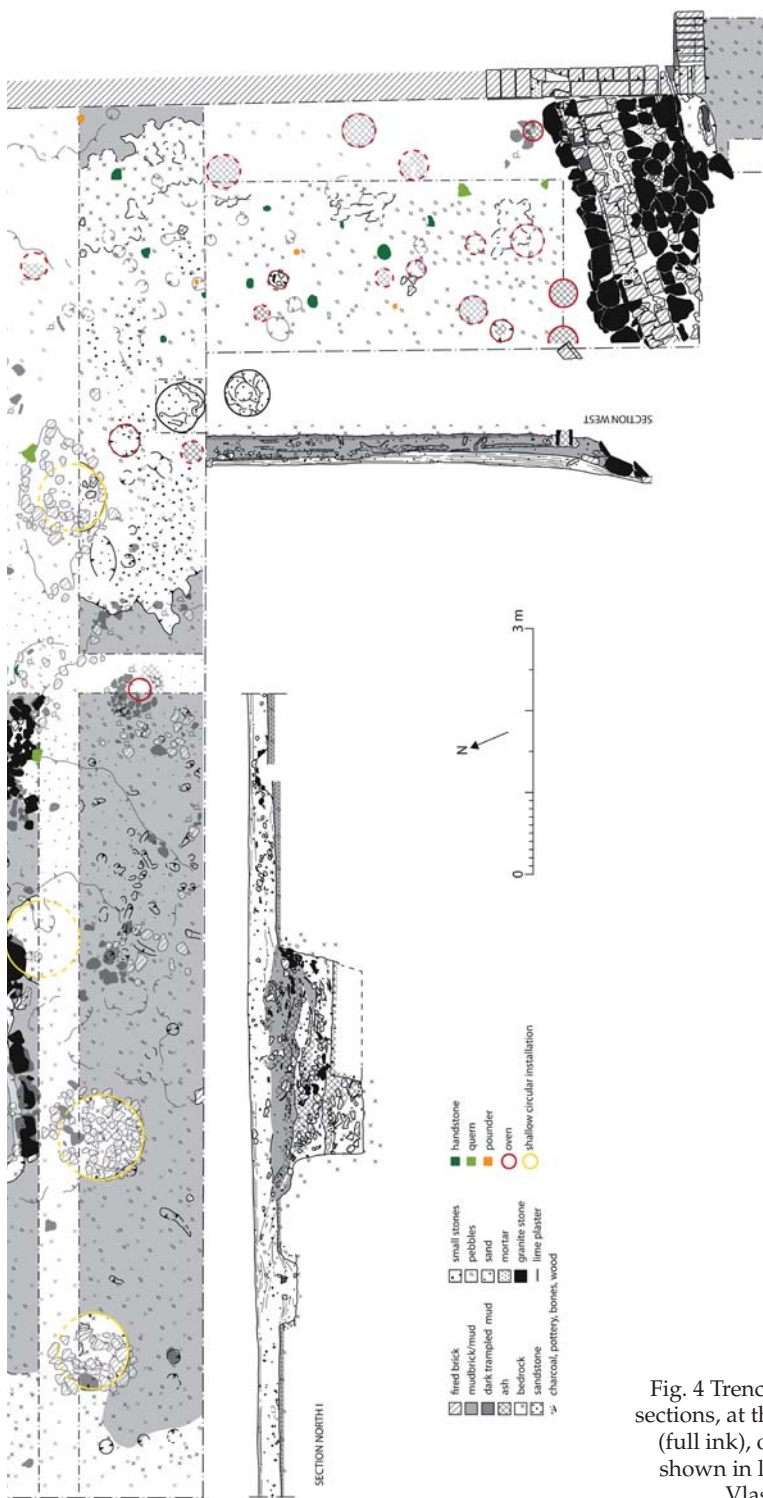
Fig. 4 Trench T66, top plan and sections, at the end of excavations (full ink), overlying strata are shown in light ink (Drawing: Vlastimil Vrtal).

Trench T66 [Fig. 4; Pl. 4] was set in the area of the southwestern corner of the palace. The trench consisted of two parts; the eastern part had dimensions of 3.0×9.0 m and covered the area immediately to the west of the exterior wall of the palace and a section of wall WBN 172; the western part had dimensions of 14.0×3.0 metres and covered the open space further to the west. An extension was later added in the south (1.0×2.0 m) in order to document the thickness of wall WBN 172 and locate the position of the corner of the palace.

The trench was dominated by the western exterior wall of the palace (FEA 227) and wall WBN 172 (FEA 226) commencing from it towards the so-called Isis Temple Complex (WBN 300). The exterior wall was built of fired bricks for casing and mudbricks for the core. The foundations on the western face consisted of bricks laid on their long sides, mostly vertically and resting directly on bedrock, although bricks laid on their broad sides were used as well. Unlike on the southern and eastern side, no protruding foundation platform was employed. In the southwestern corner, a brick laid on its broad side was used in the foundations.

Wall WBN 172 was built of large coarse-grained granite stones of local origin and fired bricks. The latter material was used in the upper section of the northern face, and

judging from random occurrence of plaster on the bricks, it was recycled from an older structure. The wall was ca. 1.2 m thick in its upper part. The presence of plaster coating on the face of the exterior wall of the palace covered by wall WBN 172 indicated that the latter wall was built later than the palace. This conclusion was further supported by a circular pit partly underlying wall WBN 172, in which a cavetto cornice brick was found, clearly originating from the palace. Similar to wall WBN 171 (cf. Onderka *et al.* 2015: 98), wall WBN 172 was thus likely built only at the time of the gradual disintegration of the palace. The finding of the brick as well as numerous detached decorated plasters in the wider area also indicated the presence of a cavetto cornice at the crown of the exterior wall in the SW-corner.

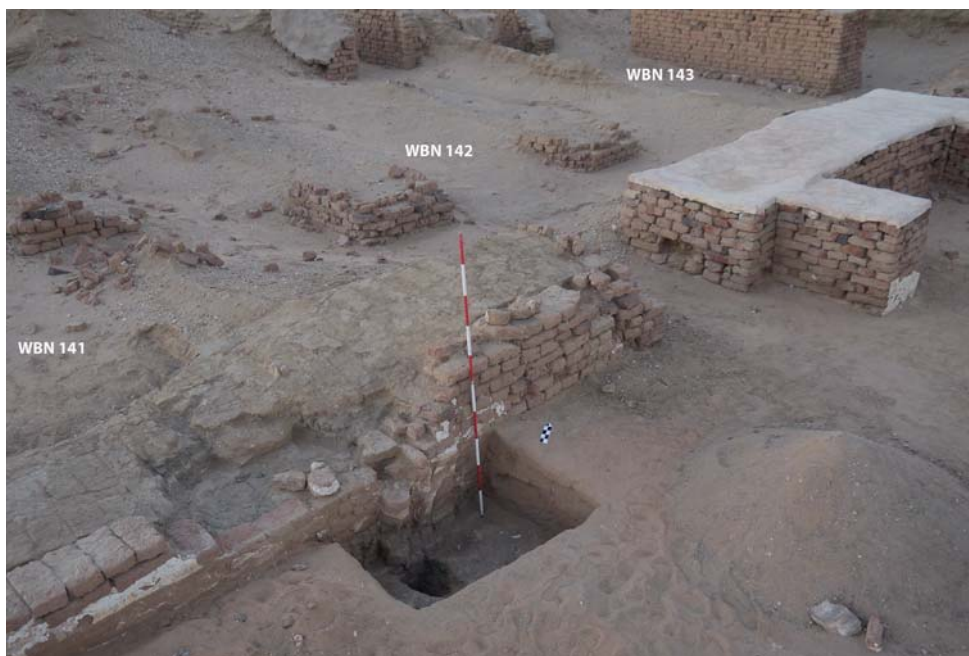
Pl. 5 The southern double torus moulding preserved *in situ* in the eastern exterior wall of the Palace of Amanishakheto (Photo: Vlastimil Vrtal).

Near the entrance to room WBN 142, remains of a double torus moulding were uncovered *in situ* (cf. Hinkel – Sievertsen 2002: Pl. IX.75, “Detail D”; Onderka *et al.* 2018:

141) [Pl. 5]. Traces of polychrome decoration in red and yellow were noted on lime plaster coating, which allowed tentative reconstruction of the original decoration of the architectural element.

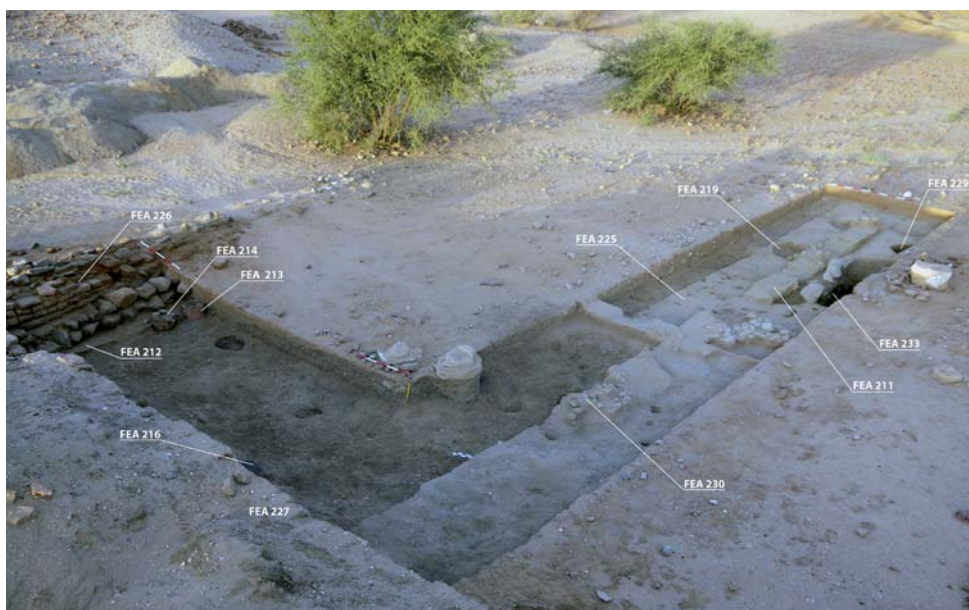
Pl. 4 Trench T66 at the end of excavations, viewed from the east (Photo: Vlastimil Vrtal).
